# Poly-si extensions and etching residues as a reliability risk

Peter Jacob

**Abstract** Even in latest technologies, poly-silicon-related failures are well-known as a reliability risk. Due to the fact, that polysilicon reoxidizes in subsequent processing, physical failures frequently do not occur as time-zero functional failures. However, the thin reoxidation can be cracked by voltage pulses during field application. This paper describes the most important mechanisms like particles, stringers, trimming-fuse recombinations and polySi-extensions with respect to failure diagnosis, screening and reliability aspects.

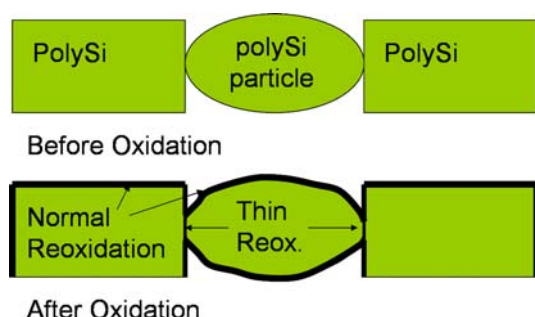
**Fig. 1** At the touching points, the oxygen has no direct access to the polySi surface. At such points, the oxidation attack appears only from the side (here top and bottom of the touch point), resulting in a minor oxide thickness

LDD techniques, etc.) in order to avoid breakdowns. If a poly silicon touched to a neighboured poly-silicon structure, the oxidation consumes material from all sides beside the point of touching. The point of touching itself will be only slightly underoxidized (Fig. 1) and therefore the oxide thickness is not clearly defined there. If locally only 2 nm oxide is achieved, this thin isolation will not withstand for long time the resulting field strength of 25 MV/cm (!). Of course, the operational conditions are different in different parts of the circuitry and it may happen that instead of 5 V, locally for example only 1 V apply as maximum voltage. The example shows, that by various influences, the isolation or non-isolation situation of such microdefects may vary over several orders of magnitude, such causing a severe reliability risk. Figure 2 shows two examples of such kind of defects.

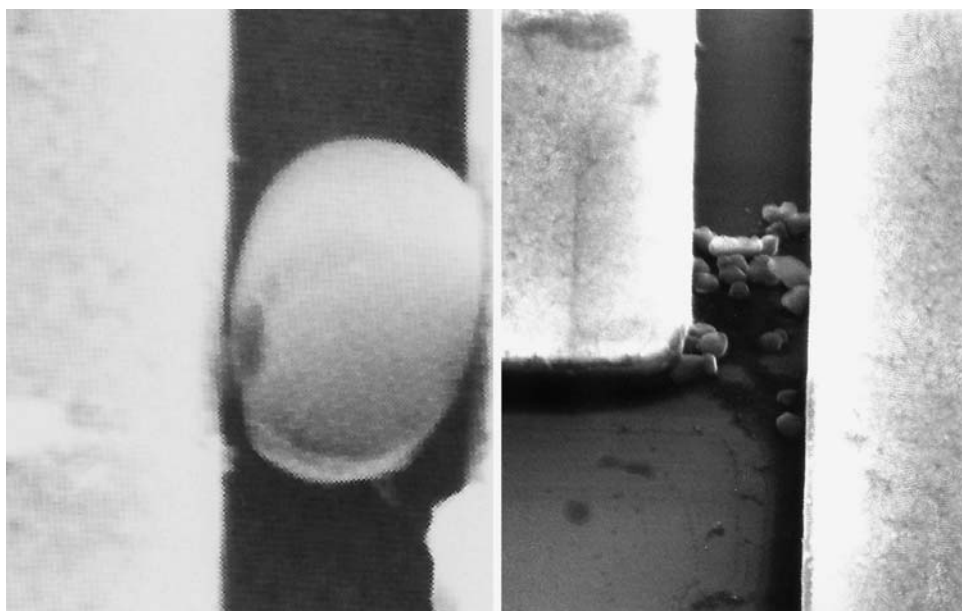
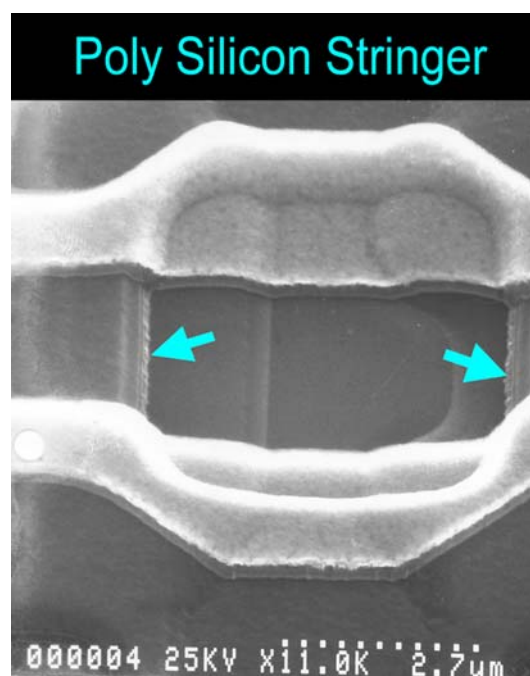
**Fig. 2** Examples for latent PolySi particle defects

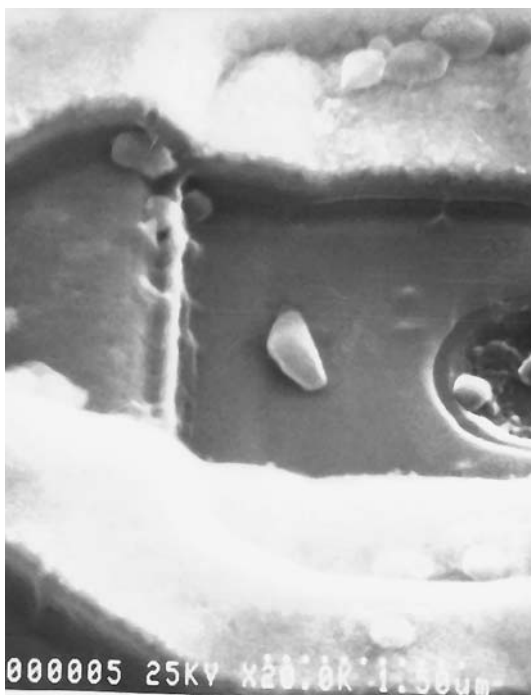
suffers the oxidation (Fig. 4). Electrically, this means that, if the stringer is thin enough, the hard and evident electrical short between the neighbored poly silicon lines degrades to a latent short by a more or less completely reoxidized poly silicon stringer. Since the stringer thickness varies along the slope border, the reoxidation will be inhomogeneous, too. If the reoxidation of such stringers is incomplete, the same considerations apply as described for the residual shorts (Fig. 5).

**Fig. 4** Reoxidized Stringer, still performing a connection between the top and bottom polySi line

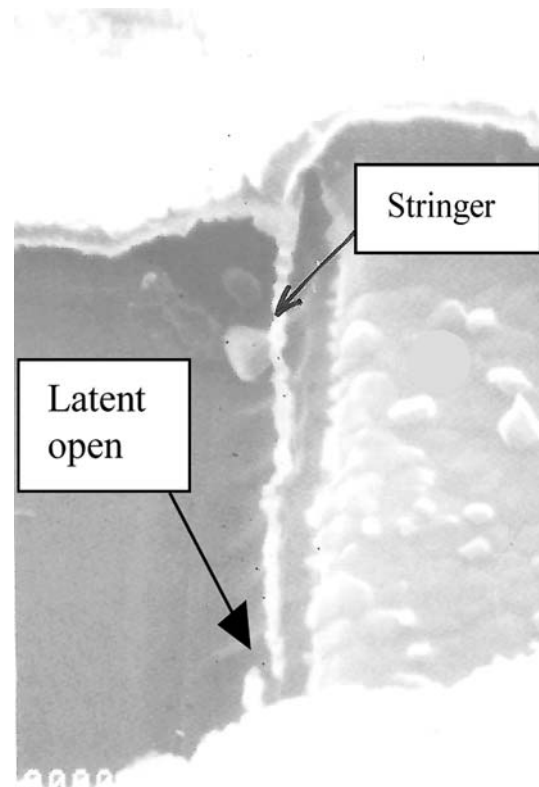
**Fig. 5** Inhomogeneous degree of reoxidation performs inhomogeneous stringer thickness; small opens may cause latent defects

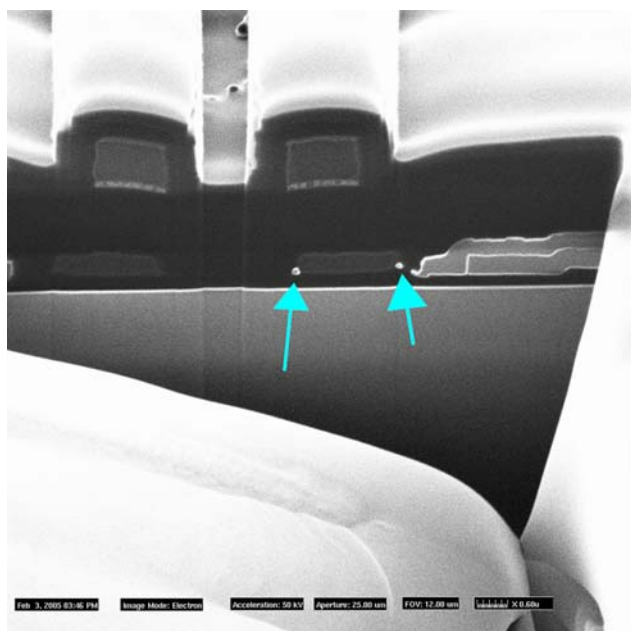
Both mechanisms a and b may happen in the field application, too. From analytical point of view, it can be added that FIB cross sections of stringers show up clearly by passive potential contrast, whether they are isolated (=dark) or perform any remaining connection to the circuitry (=bright), see Fig. 6.

**Fig. 6** FIB cross section of a Si stringer: the bright points show that both stringers are connected to backward circuitry

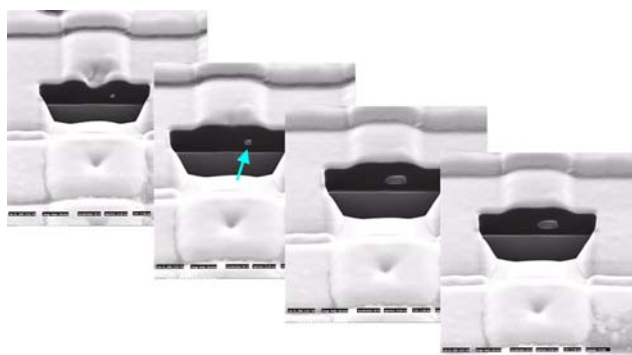
**Fig. 7** Sliced FIB cross section through a poly fuse stringer, beginning at the center (*top left*), ending at the full size of the fuse's poly line (*right bottom*)

The trimming of such fuses usually is performed by laser fuse-blow. If, however, the laser spot is misaligned or too weak in energy, it happens that the fuse is incompletely blown, leaving small stringer on one side of the poly-silicon fuse. Thus, the fuse is still not open, giving probably malfunctions or parametric no expected behaviour to the circuitry (Fig. 7).

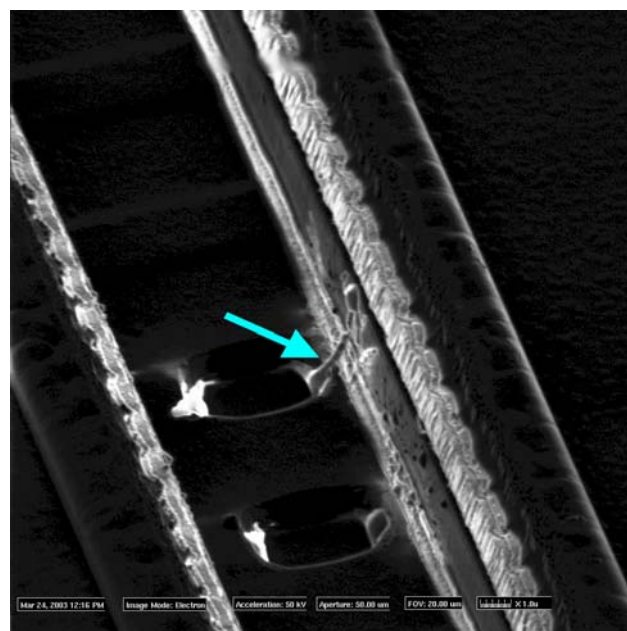
**Fig. 8** Laser-trimmed polySi-fuses; the drops partially connect them to a metal ring, such either recombining them or giving connection to neighbour fuses

and short-circuit one of the fuse-line-ends to the metal frame. Also, the drops can completely recombine the fuse by bridging it with molten poly silicon, see Fig. 8.

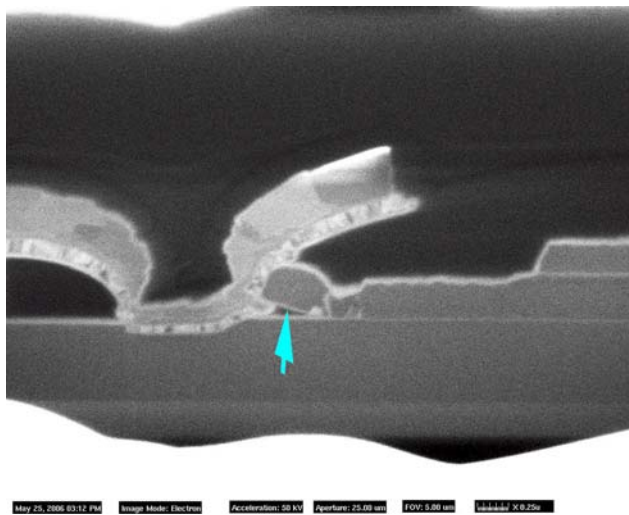
**Fig. 9** Poly1-Si residue, causing a latent short between the contact and the neighbored first polySi. Note the small white lines at the border of the particle, indicating its reoxidation

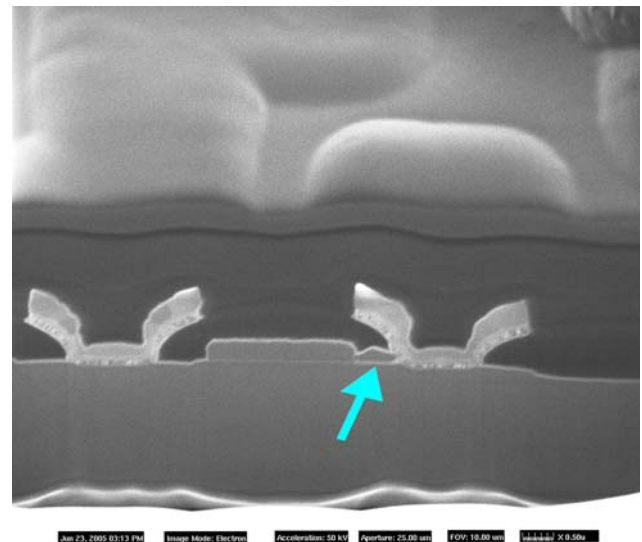
**Fig. 11** PolySi extension, causing a hard short between polySi and contact

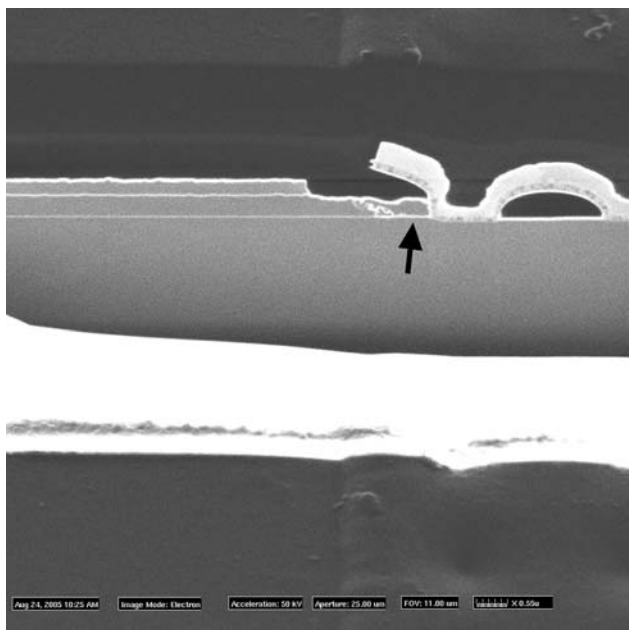
**Fig. 10** Poly2-Si residue, performing the same mechanism like shown in Fig. 9. Again, reoxidation can be seen by the small white lines

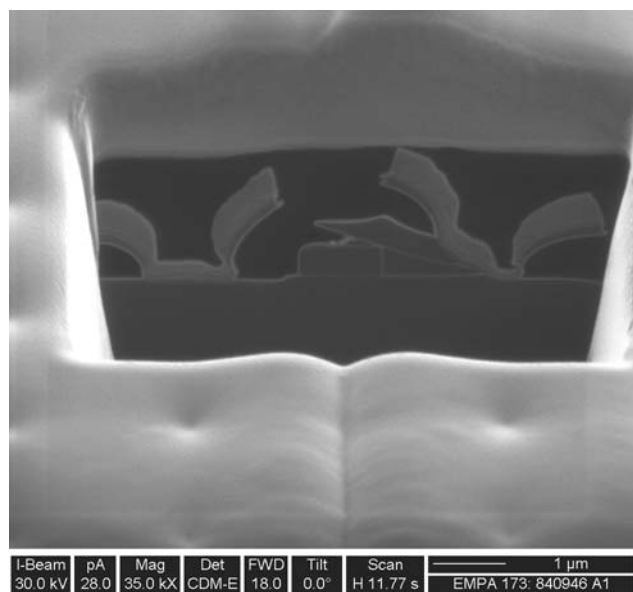
shown even unbelievable structural damage, without showing time-zero functional failures. The example shown in Fig. 13, however, shows proper oxidation lines along the structural damages. Knowing such risks, already many semiconductor -manufacturers and also some end users perform overvoltage stress testing (Bauch 1998; Khalil and Wey 2001). The intention of such testing, done by at least 25% above upper Vdd spec limit voltage, is, to provoke

**Fig. 13** PolySi residue, causing a severe—but latent—structural failure. The case was functional at final test but came to analysis as a field failure

such kind of failures at an early stage of testing and, by this, to screen the production in a customer-useful manner. However, it must be carefully considered that many integrated circuits of today include internal voltage regulators, which prevent the device-internal circuitry from suffering the overvoltage. In such cases, an overvoltage test would not be useful to stress and screen such failures.
