CASE REPORT

Early failure of a non-cemented femoral stem after minimal-invasive total hip arthroplasty: cause analysis and classification

Jan P. Benthien · Wolf Siepen

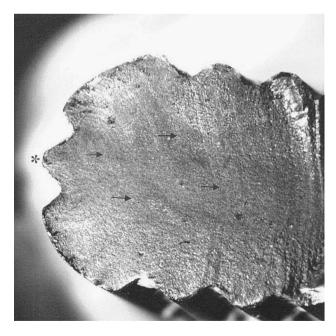
The stem was stressed in a monotonous way without a single or peak overload. The fracture initiated at the most lateral groove of the stem under progressive fissuring

Fig. 2 Cross-section of the fracture site. The most lateral groove (*asterisk*) is the initiation point for the lines that indicate fatigue stress (*arrows*) from lateral to medial. Magnification $\times 10$. Photograph with kind permission by DePuy Johnson and Johnson, Switzerland

(Figs. 2, 3). The hardness test was appropriate so a fracture due to failed raw material could be excluded.

A wide femoral entrance with narrowing of the dia- and metaphysis (a champagne flute design) seems to predispose varus alignment of the implant [12]. In this position, repetitive excess bending and twisting may produce fatigue fractures initiating in the lateral parts of the prosthesis (Figs. 2, 3). Therefore, it is important to rule out varus positioning or an undersized implant intra-operatively. The use of fluoroscopy is advised.

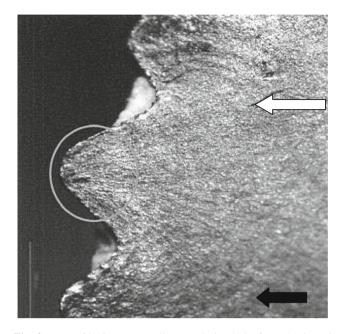
Fig. 3 *Lines (black arrow)* radiate semi circularly from the lateral groove (*circle*). A *crack* radiating from the *lines* may be noted (*white arrow*) indicating fatigue fracture. The lateral groove received the peak stress. Magnification $\times 20$. Photograph with kind permission from DePuy Johnson and Johnson, Switzerland
