Dynamic testing of a four-storey building with reinforced concrete and unreinforced masonry walls: prediction, test results and data set

Abstract This paper presents the results of a series of shake-table tests on a half-scale, four-storey building with reinforced concrete and unreinforced masonry walls. Due to the lack of reference tests, the seismic behaviour of such mixed structures is poorly understood. The test unit was subjected to several runs of increasing intensity yielding performance states between minor damage and near collapse. Before the test, the expected peak table accelerations leading to different limit states were estimated using the capacity spectrum method, and the predicted values corresponded rather well to actual sustained accelerations. Next to these analyses, the paper describes the test unit, instrumentation and input motion, and comments on the response of the mixed structure in terms of damage evolution and global response quantities, such as force–displacement response and drift and acceleration profiles. The raw and post-processed data sets are made publically available, and all relevant information with regard to data organisation and post-processin

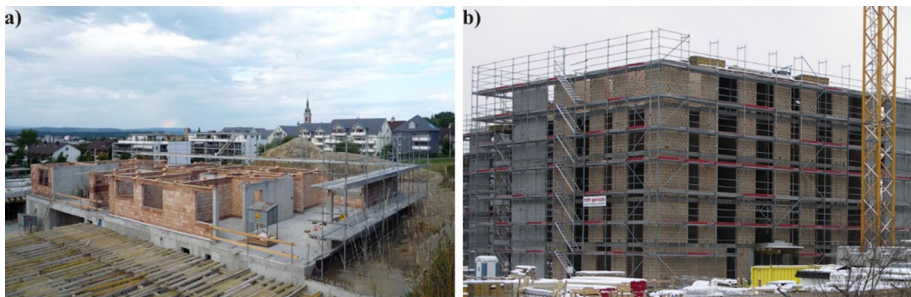
Fig. 1 Examples of new buildings with RC and URM walls in Switzerland (Photos: Thomas Wenk)

The recently completed European research project SHARE, which aimed at harmonising the seismic hazard maps of Europe, reveals that countries of low to moderate seismic hazard in stable continental regions have higher spectral values than previous studies showed (Giardini and Wössner 2012). Once these new insights are reflected in seismic hazard maps of European building codes, the seismic performance of a large number of existing buildings will need to be reassessed. Among the most vulnerable structures are unreinforced masonry (URM) structures. URM structures that do not satisfy the seismic design check are often reinforced by adding reinforced concrete (RC) walls or replacing selected URM walls by RC walls. In some countries of moderate seismic hazard, such as Switzerland, new residential buildings of three to six stories are already today conceived as mixed structures with RC and URM walls. In typical building configurations, the URM walls outnumber the RC walls. The RC walls often accommodate stair cases or lift shafts and are therefore also often situated at the perimeter of the building. Examples of new and existing buildings with URM and RC walls are shown in Figs. 1, 2.

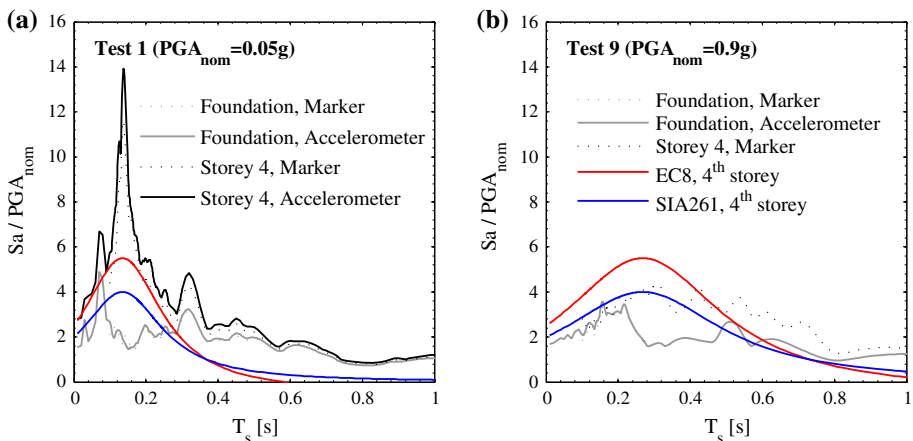
Fig. 16 Storey response spectra: Comparison of storey response spectra in codes to the storey response spectra computed from the accelerations that were recorded for the fourth storey during the first (a) and last (b) test. For comparison, the response spectra for the recorded foundation acceleration is also shown

Figure 16 shows storey response spectra of the top storey for the first and last run. The storey response spectra computed from the recorded signals are compared to the storey response spectra in two codes (i.e., Eurocode 8 [CEN 2004b] and the Swiss standard SIA 261 [2003]), which are provided for the design of non-structural elements. In Eurocode 8, the spectral acceleration of a non-structural element with a fundamental period T_a and placed at level Z above the foundation within the structure is given as:
