CARDIOVASCULAR FLASHLIGHT

Multimodal functional evaluation of severe kinking of an ascending aortic prosthesis in a patient with embolic stroke

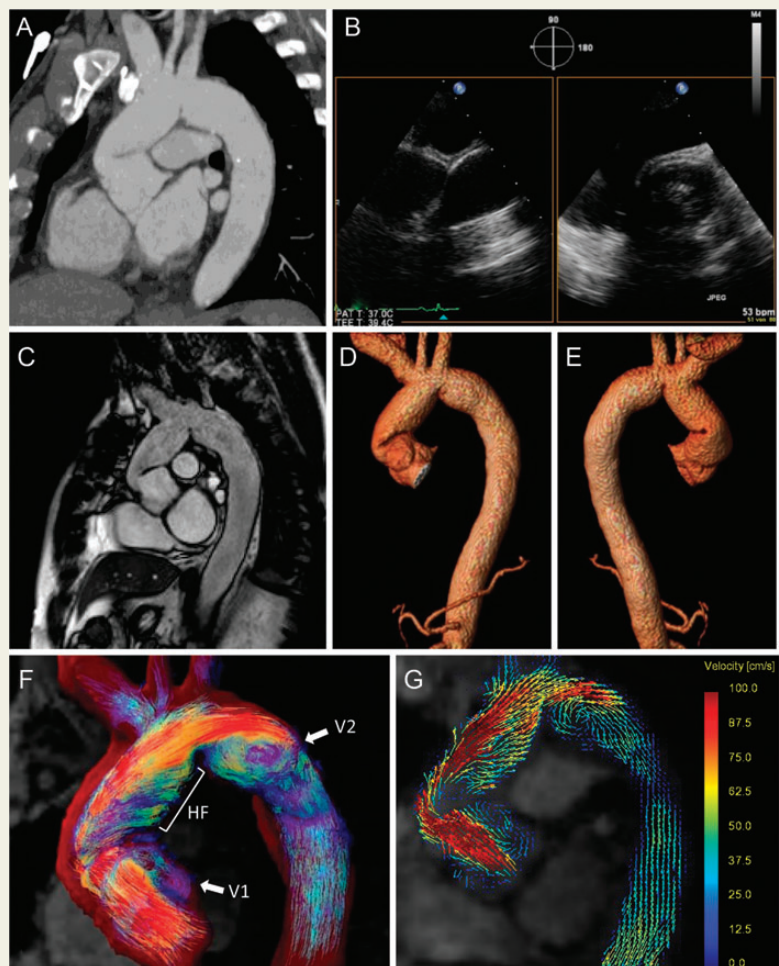
Vascular ultrasound of the carotid arteries revealed only minimal atherosclerosis; 48-h holter monitoring was normal. A transthoracic echocardiography showed normal LV function and no evidence of patent foramen ovale. Computed tomography of the thorax (Panel A) found a septal structure in the ascending aorta that was confirmed by transoesophageal echocardiography (Panel B) and was interpreted as kinking of the aortic prosthesis.

Cardiovascular MRI was performed for further evaluation. MR-angiography of the aorta revealed a proximal twist and adjacent double kinking of the graft (Panels C–E, Supplementary material online, Movie S1). Flow-sensitive 4D-MRI was used to derive information on the haemodynamics inside the prosthesis. Three-dimensional pathline visualization (GyroTools, Switzerland) showed pronounced flow disturbance with formation of vortices and helical flow (HF) (Panel F, Supplementary material online, Movie S2). The first vortex (V1) in front of the proximal kink exhibits low flow velocities, implying thrombogenic potential (Panel G: flow vector field). Between the two kinks, enhanced systolic peak flow ($V_{\max} = 1.5$ m/s) from the first stenosis hits a HF pattern that directs pathlines to the supra-aortic vessels. A second vortex (V2) is located behind the distal kink.

Kinking of an aortic prosthesis causes unphysiological flow patterns and pressure gradients with the potential risk of thrombus formation and subsequent systemic embolism. Since aortic prostheses show a tendency to grow after implantation, graft-expansion is a potential cause for the formation of kinking folds. Repeat surgery would be indicated in cases of severe pressure gradients over the kinks, which was not present in our patient. As there are no data out on this particular issue, anti-aggregatory or anti-coagulatory strategies remain empiric. In our patient, treatment with clopidogrel was initiated and short-term outpatient follow-up was scheduled.
