Enamel loss and adhesive remnants following bracket removal and various clean-up procedures *in vitro*

Sacha Ryf*, Simon Flury**, Senthamaraiselvi Palaniappan***, Adrian Lussi**,
Bart van Meerbeek*** and Brigitte Zimmerli**,***

SUMMARY This study evaluated the enamel loss and composite remnants after debonding and clean-up. The tested null hypothesis is that there are no differences between different polishing systems regarding removing composite remnants without damaging the tooth surface. Brackets were bonded to 75 extracted human molars and removed after a storage period of 100 hours. The adhesive remnant index (ARI) was evaluated. The clean-up was carried out with five different procedures: 1. carbide bur; 2. carbide bur and Brownie and Greenie silicone polishers; 3. carbide bur and Astropol polishers; 4. carbide bur and Renew polishers; and 5. carbide bur, Brownie, Greenie and PoGo polishers. Silicone impressions were made at baseline (T0) and after debonding (T1) and polishing (T2) to produce plaster replicas. The replicas were analysed with a three-dimensional laser scanner and measured with analytical software. Statistical analysis was performed with the Kruskal–Wallis te

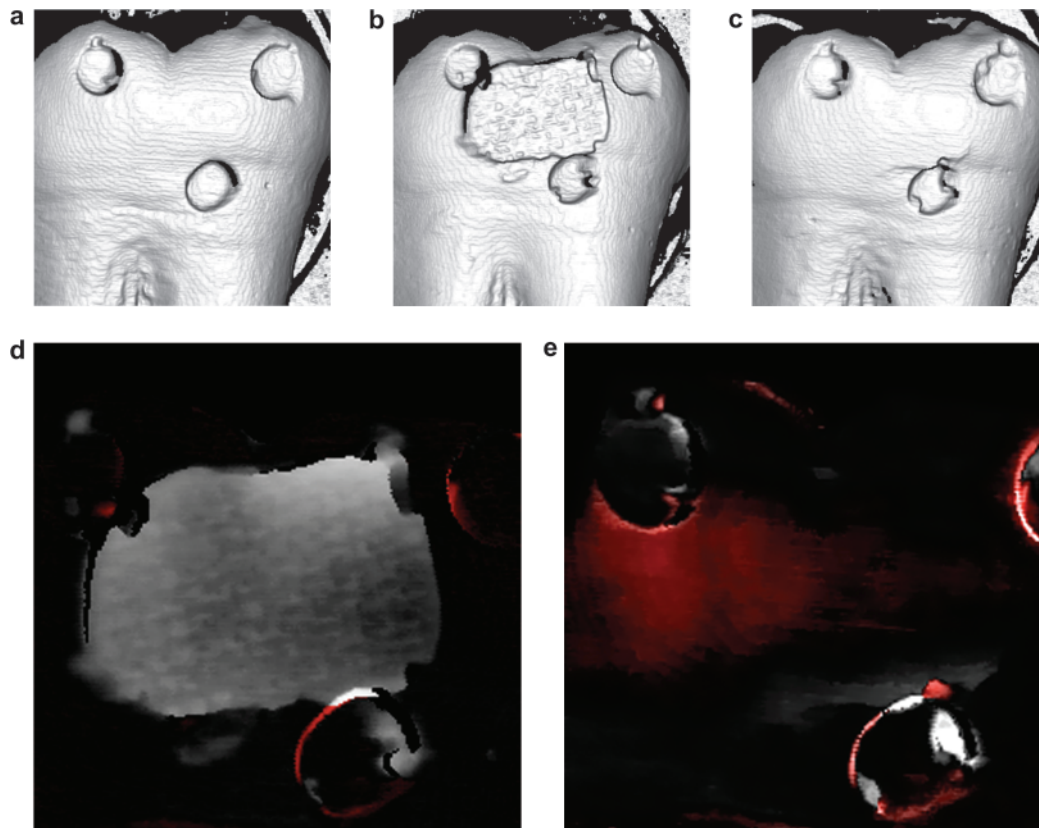
Figure 1 Images at baseline (T0). (a), after bracket removal (T1) (b) with a clearly visible resin remnant, after clean-up (c) and differences after overlapping baseline T0 and T1 (d). Resin remnant is shown (white) and (e) T0 and T2. Loss of surface substance (red) and resin remnants (white) are visible.

Silicone impressions (President microSystem light/regular body; Coltène/Whaledent AG, Altstätten, Switzerland) were taken of the buccal surfaces of the teeth. Baseline models (T0) were produced in dental stone (Fuji Super Hardrock, GC, Leuven, Belgium) and scanned with the 3D imaging device (Laserscan 3-D Pro; Willytec GmbH, Gräfelfingen, Germany) to establish T0 data (Figure 1a).

The brackets were debonded by gently squeezing with Weingart pliers (3M Unitek). A second impression was taken of the buccal surfaces of the teeth after debonding (T1), and replicas were made in dental stone (Figure 1b).

A third impression (T2) was then taken of the surface of every tooth (Figure 1c).

By matching T1 to T0, the height and volume of composite remnant was recorded (Figure 1d). If present, enamel defects were recorded in terms of depth of lesion and volume loss. Therefore, the areas of interest analysed from the differential image were selected and separately measured. Comparing the T2 with the T0 models, vertical and volumetric changes in surface geometry were measured (Figure 1e). However, enamel breakouts that were recorded by superimposing T1 on T0 were always at the margin of the area of interest and excluded from further surface analysis. If defined, composite remnants were left, and the height and volume of the remnants were separately recorded.

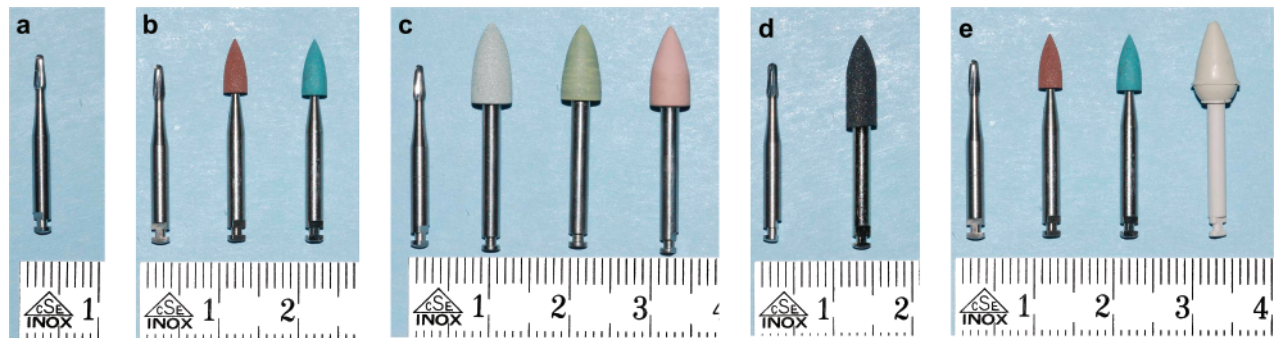
Figure 2 (a) Group 1 (carbide bur). (b) Group 2 (carbide bur, Shofu Brownie and Shofu Greenie). (c) Group 3 (carbide bur, Astropol polishing system: F, P, and HP). (d) Group 4 (carbide bur, Renew System). (e) Group 5 (carbide bur, Shofu Brownie, Shofu Greenie, and PoGo polisher).

The residual adhesive on each tooth in the five groups was removed using one of the five following protocols: group 1, carbide bur (Figure 2a); group 2, carbide bur followed by Brownies and Greenies (Figure 2b); group 3, carbide bur followed by Astropol F, P, and HP polishers (Figure 2c); group 4, carbide bur followed by the Renew System (Figure 2d); and group 5, carbide bur followed by Brownies and Greenies and finished with a PoGo polisher (Figure 2e).

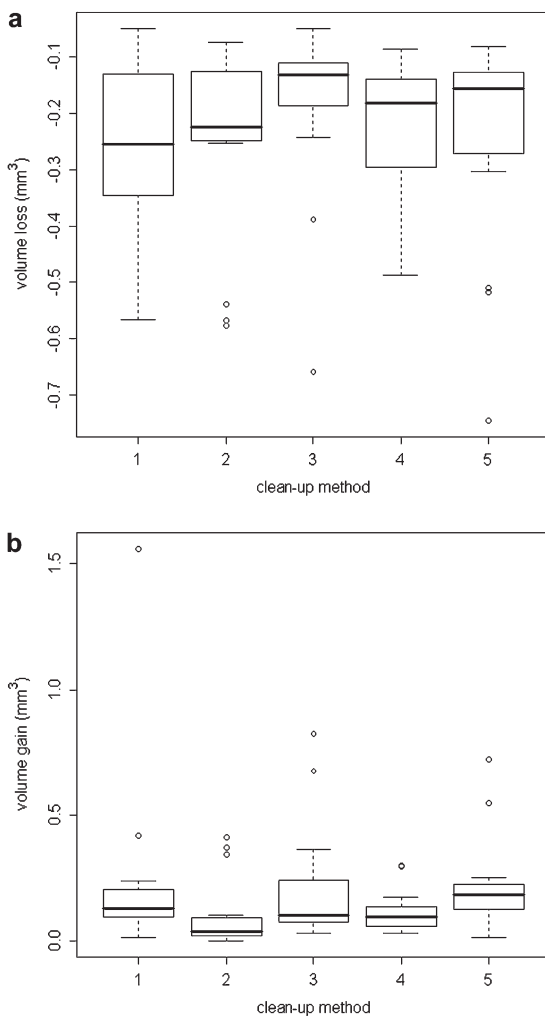
Figure 4 Loss of volume (a) and composite remnants (b) after clean-up with five different methods. Groups as listed in Table 2.

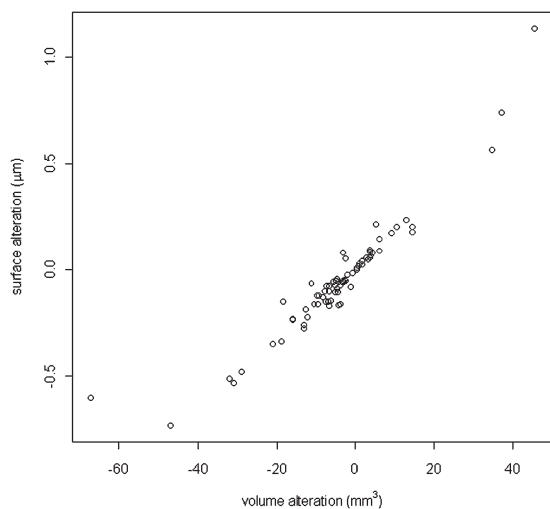
Figure 6 Correlation of linear versus volumetric surface changes. Spearman rank correlation coefficient = 0.95.

other groups showed no significant differences, although the difference between groups 4 and 5 was almost significant ($P = 0.04$; but not significant due to Bonferroni correction). Comparisons of the variances of the different clean-up procedures' total volume loss and composite remnants showed that there were differences, although not significant, between the groups (Figure 4a and 4b). The least aggressive method for enamel, with minor removal of hard dental substance, was found in group 3. The method in group 1 seemed to be more aggressive. However, all methods left some remaining composite on the tooth surface, with group 5 leaving the most. Spearman correlation showed a clear linear correlation of volume alteration to linear surface alterations (correlation coefficient: 0.95; Figure 6).
